**Civil Aviation Organization
Accident Investigation and Analysis Office**

Final Investigation Report of the accident on January 9th, 2011 of a Boeing 727-286, registered EP-IRP, belonging to Iran Air, which crashed in Urmia, Iran.

Finished on December 9th, 2012

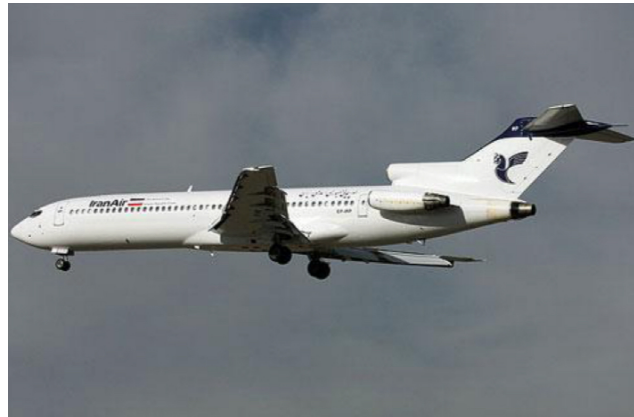
The Boeing 727 aircraft, registered as EP-IRP and belonging to Iran Air, was equipped with three engines mounted at the rear of the fuselage. Engines No. 1 and No. 3 were located on either side of the tail, while Engine No. 2, which had a different air intake configuration compared to the other two, was positioned above them.

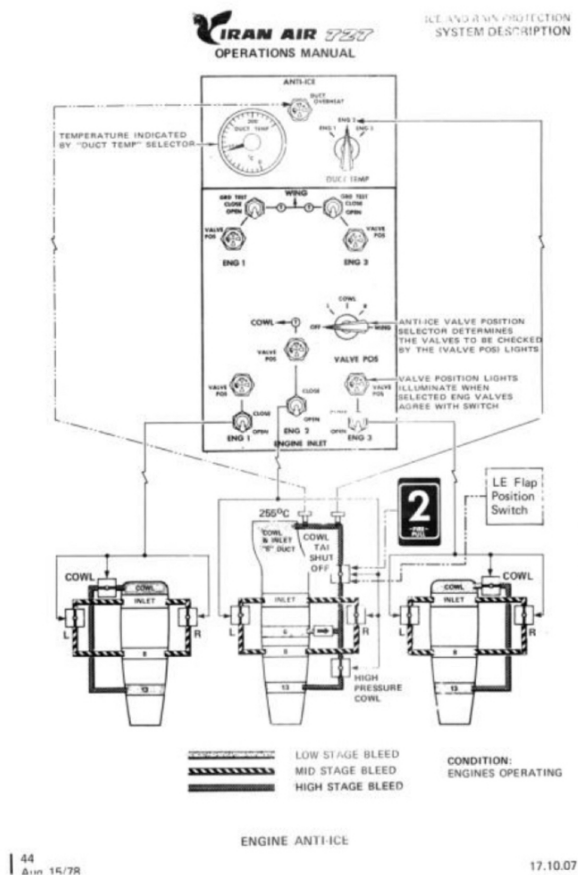
Note: According to the Flight Manual, Section Ice & Rain Protection - Page 20, when the Anti-Ice switches related to the engines are opened, the Anti-Ice Valves open. These valves provide warm air to the Inlet Guide Vanes and Nose Dome on both the left and right sides. The Cowl Valve also supplies sufficient warm air to the cowl. The next image shows the Anti-Ice system of this aircraft's engine.

If the engine power is reduced excessively in conditions where icing is likely, this will result in insufficient warm bleed air being sent to the leading edge, antennas, and other necessary parts, despite the anti-ice systems being activated. This increases the risk of ice formation.

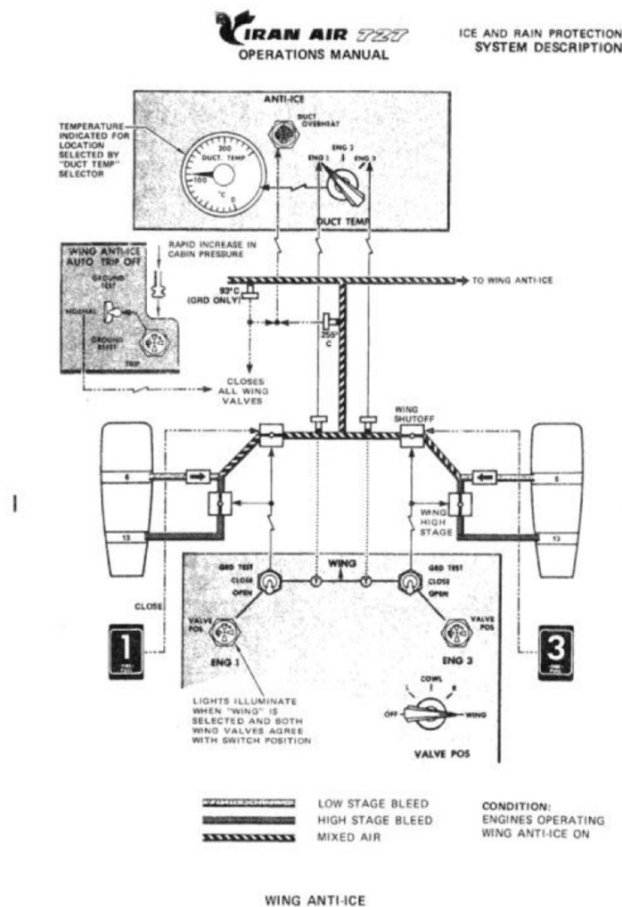
Additionally, pulling the engine fire switch will also close the Engine Wing Shut Off Valve.

The next image shows the Wing Anti-Ice system of this aircraft.

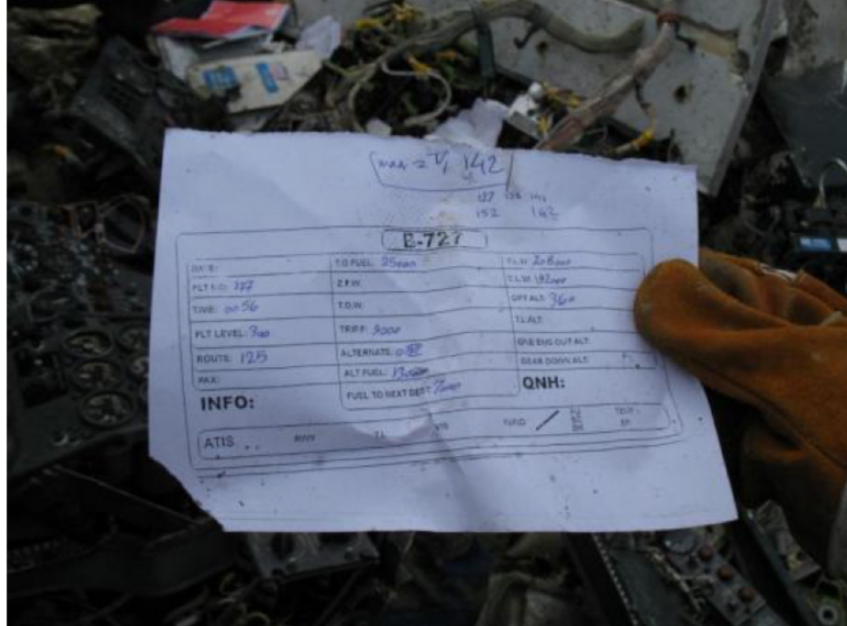
4. The image below shows a form filled out by the flight engineer, which includes information about the fuel loaded, the fuel required for the destination, the flight altitude, and the flight route.

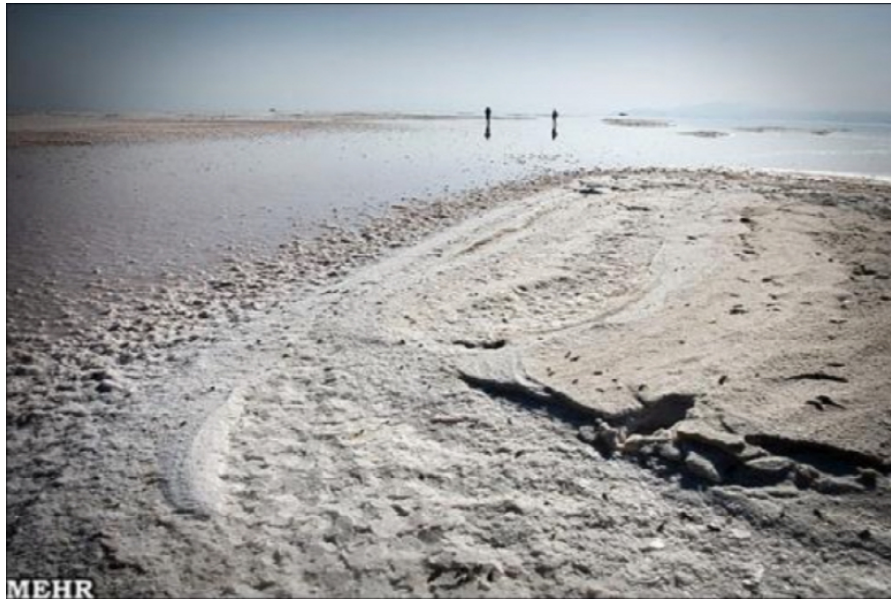
In this investigation, it was determined that Urmia Lake is one of the three saltiest lakes in the world. Due to the critical reduction in the lake's water level in recent years, as seen in the figure below, the water level has decreased, and the salt concentration has increased to 400 grams per liter.

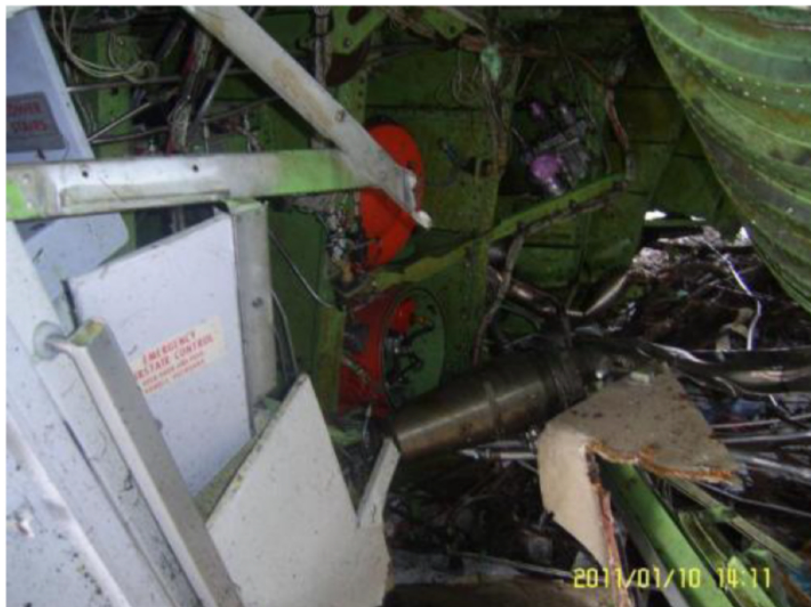
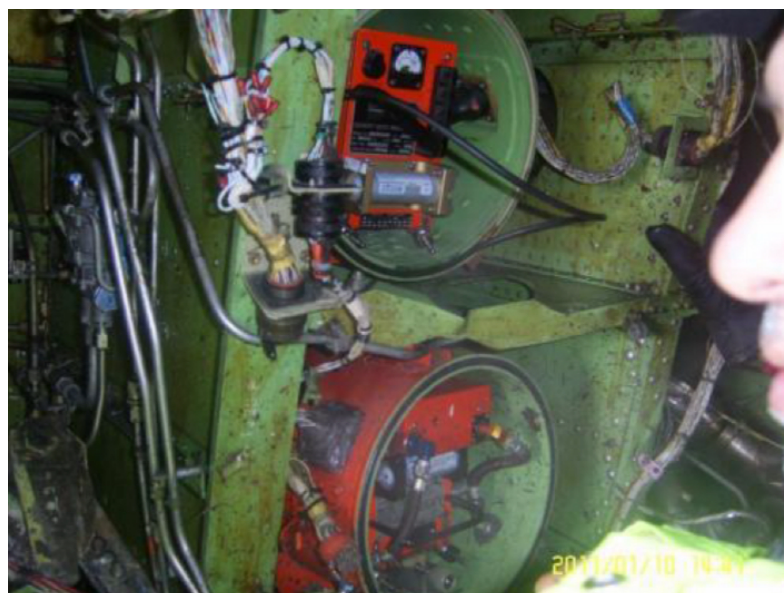
After the occurrence of this accident, the investigation team was dispatched to the crash site and proceeded to locate the FDR & CVR devices. The location of these devices is in the rear section of the aircraft, near the emergency exits. Since this part of the aircraft (Tail) was completely separated from the fuselage, the devices were found along with this section next to the wreckage of the aircraft. Fortunately, these devices were intact and undamaged, as this section did not experience severe impact.

The devices were safely located in their designated compartments, which remained intact in the rear wall of the compartment. They were immediately identified and, with coordination from the Red Crescent personnel and the use of hydraulic shears, were easily accessed. They were retrieved by a member of the investigation team from aircraft B.727, registration EP-IRP, and handed over to the accident investigation team.

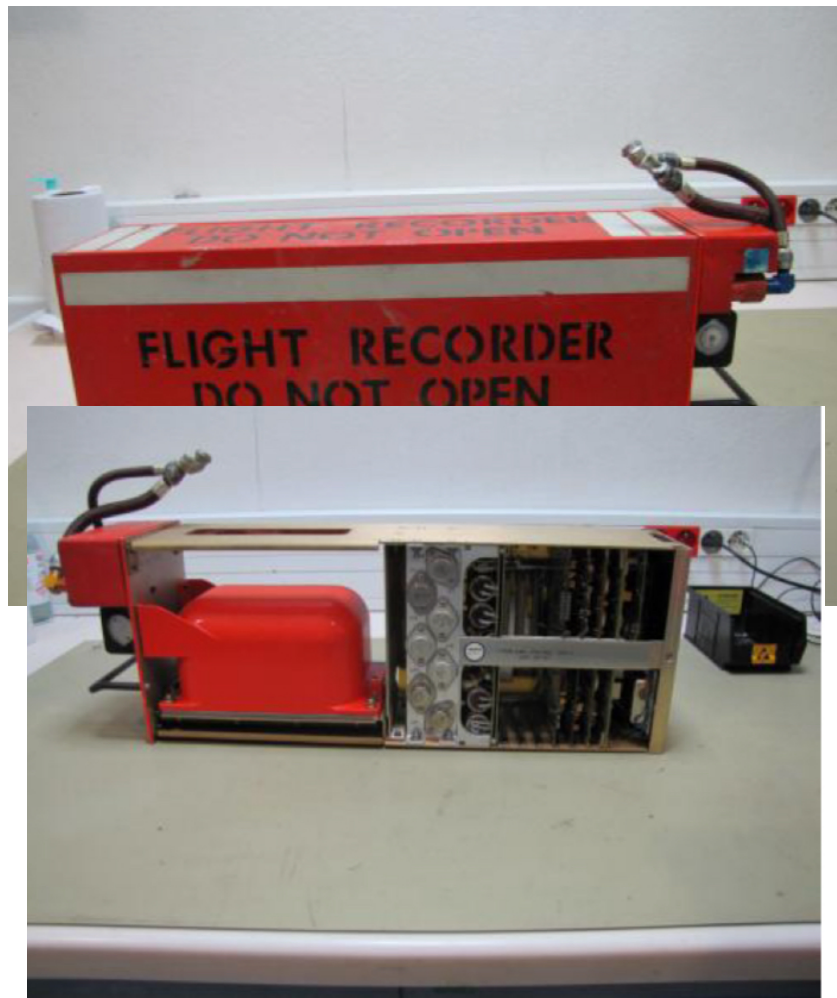
Above: The SSFDR opening

- The FDR and CVR devices functioned normally.
- Due to the possibility that one of the crew members' mobile phones was on, some recorded sounds in the CVR were partially distorted.
